**SUMMARY OF FACTS AND STATEMENT OF OPINION
F-22A ACCIDENT
20 OCTOBER 2005**

The accident board was convened to investigate the 20 Oct 2005 Class A accident involving an F-22A aircraft, S/N 03-4045, assigned to the 27th Fighter Squadron, 1st Fighter Wing, Langley Air Force Base (AFB), Virginia (VA).

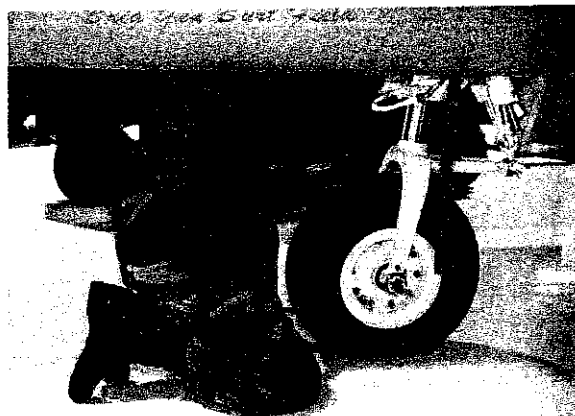
The MCC physically put his upper torso up into the gear well and used his right hand to remove the pin (Tab V-1.12). (See Figure 4)

Figure 4 – Example of an individual's position as he attempts to remove the NLG pin
